TSE Team Report

Osgoode Interlocking Incident Report

February 3, 2021

TRANSIT SYSTEMS ENGINEERING

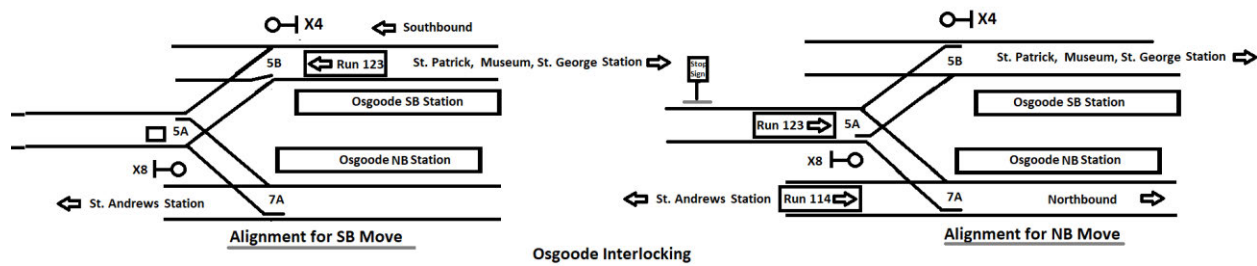
Resulting Investigation

The events leading up to this incident started on June 11th, 11.53 p.m. and continued to 12:10 a.m. June 12th, 2020, and are summarized as follows:

- The southbound motor-person (operator) of Run 123 accepts route to Osgoode pocket track southbound and stops before reaching the marked stop position. This leaves the rear of the train clear of the Osgoode interlocking limits. However, the train location prevented the northbound operator off Run 123 from clear sighting of Osgoode Interlocking Signal X8.

- The second northbound switch 7A required to be in reverse position for a move into the station from Osgoode pocket track did not move because it was locked normal by the signal system for the approach of Run 114 entering Osgoode Station platform on the mainline.

- Run 123 then proceeds out of Osgoode Pocket Track northbound in manual and without any clear communications with the Operations Control Center. The X8 signal protecting the Osgoode Interlocking northbound move did not change from its restrictive indication but was hidden from the northbound operator due to the position of the train.

- Run 123 came to a stop 5.8 meters before fouling revenue service Run 114.
